# *Spec-Pro Home Inspection Services*

## Property Inspection Report

1230 Bear Orchard Rd, Granbury, TX 76048  
Inspection prepared for: Sample Report  
Date of Inspection: 6/24/2022 Time: 1pm  
Age of Home: 2016 Size: 3,750 sqft  
Weather: Clear and Hot (102°F)  
Single-Family, 3-Bedroom, 3-Bath,  
House Faces: North  
Number of Persons on Property: 4

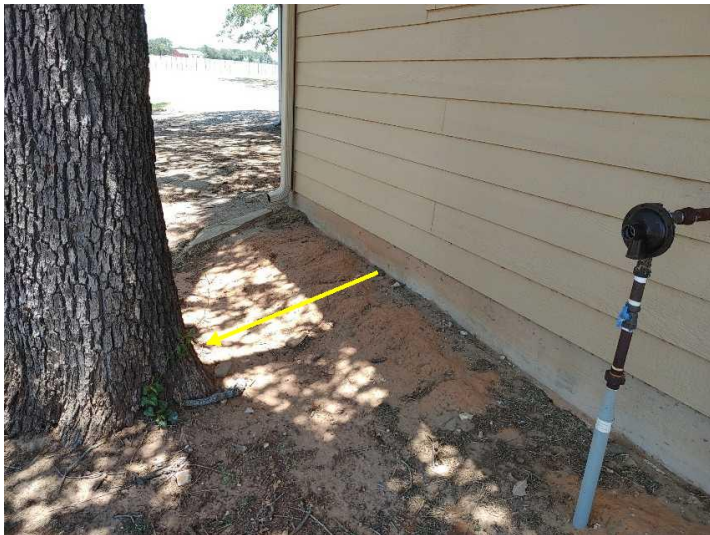
*Large tree growing within 10 feet of structure*

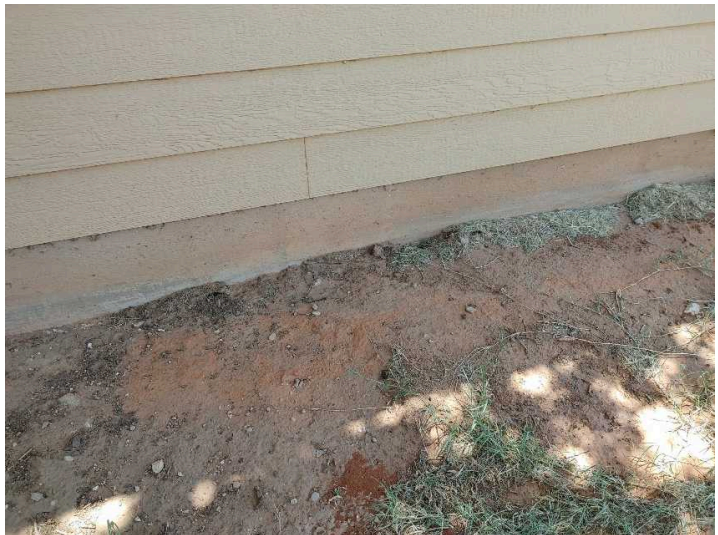
- Due to the expansive nature of soils, and dryer than normal conditions, shrinkage in grading from lack of soil moisture content and the absence of a watering maintenance program can significantly affect foundation performance if not corrected. Maintaining proper soil hydration is crucial in protecting your structure from foundation related issues, that is considered an important maintenance item and should be applied

*Dry soils around foundation should be hydrated*

- Dry soils next to structure should be kept properly hydrated in the hotter months to protect home from foundation related issues
- FYI: A daily watering regiment around the foundation perimeter should be in place during persistently hot-dry weather conditions, which can protect the slab from potential failure if correctly applied

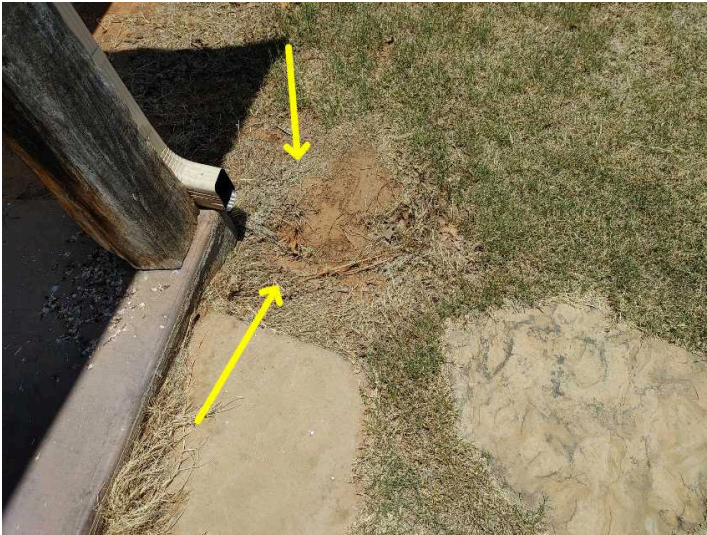
*Missing splash-blocks and/or underground drainage system*

- **Low soil observed at one or more sides of the structure and recommend additional backfill**
- **Underground drainage source is advised at front of structure**

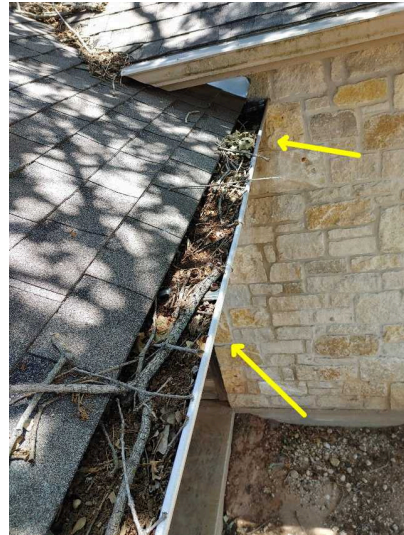
*Rain gutters should be kept clear at carport*

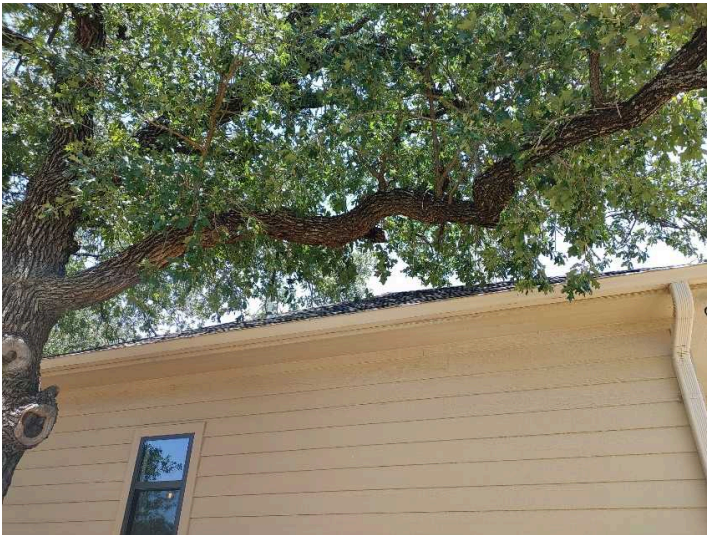
*Tree limbs in contact with roof deck*

- Tree limbs and high foliage in contact or hanging near the roof covering, should be trimmed back a minimum of 6 feet from the roof deck, to avoid damage to the roofing components
- The house was equipped with a built-in gutter system
- **Tree limbs and high foliage in contact or hanging near roof decking should be trimmed minimum 6 feet, to avoid damage to shingle components. This condition can become conducive to the roof covering until corrected**
- **Various shingle tabs lifted or detached from roof deck**
- **Some granule loss noted at various roofdeck locations**

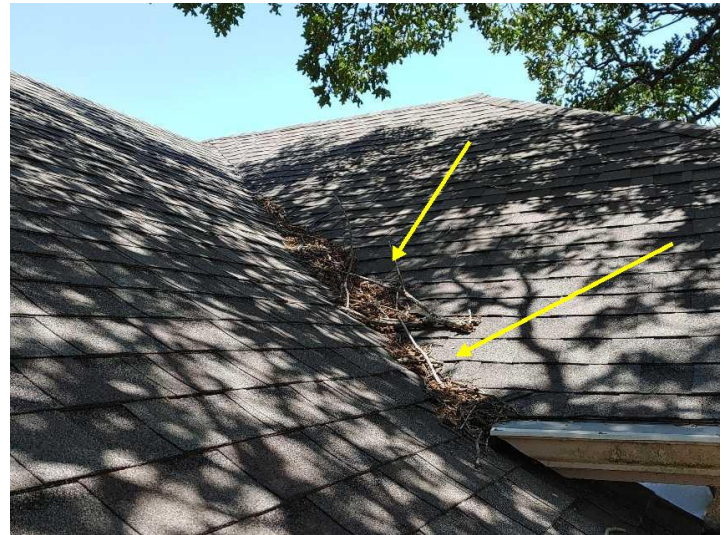
*High foliage near roof should be trimmed back*

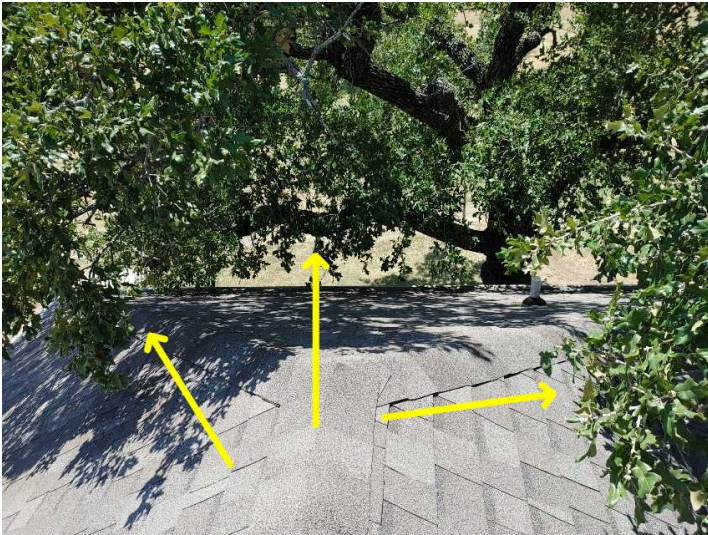
*Tree limbs should be trimmed back 6 feet from roofdeck*

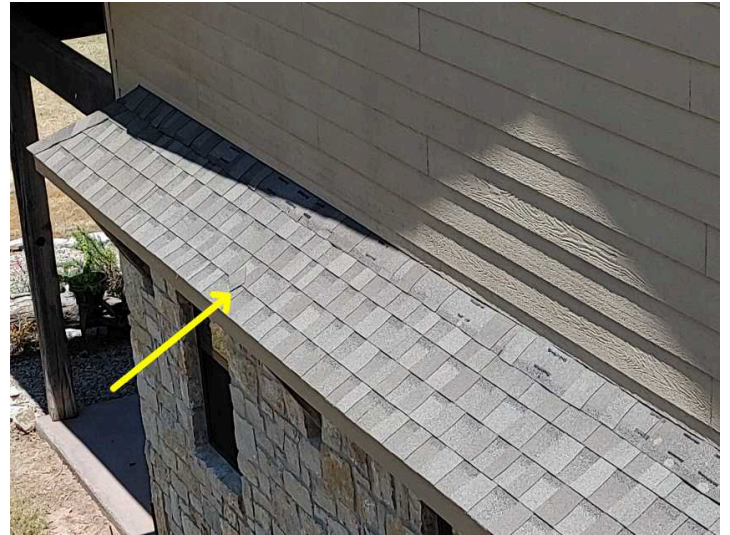
*Loose shingle tab(s)*

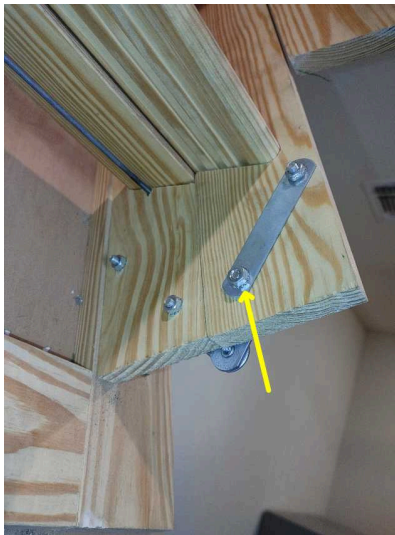
- Roof Structure: Rough framing, Hip-roof type
- The attic structure was observed to be truss framed at barn-house
- Bolt hardware loose or damaged at attic pulldown ladder location(s). Advise correction as necessary to protect from personal injury

*Loose hardware bolts*

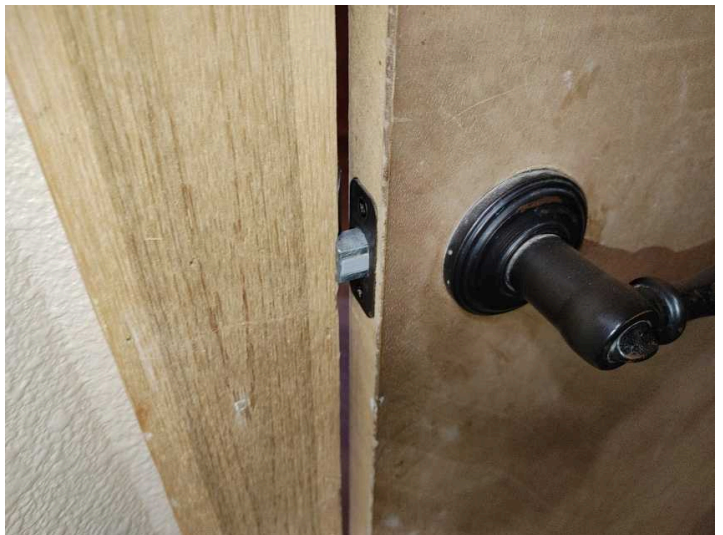
Door latch inoperative at interior bedroom

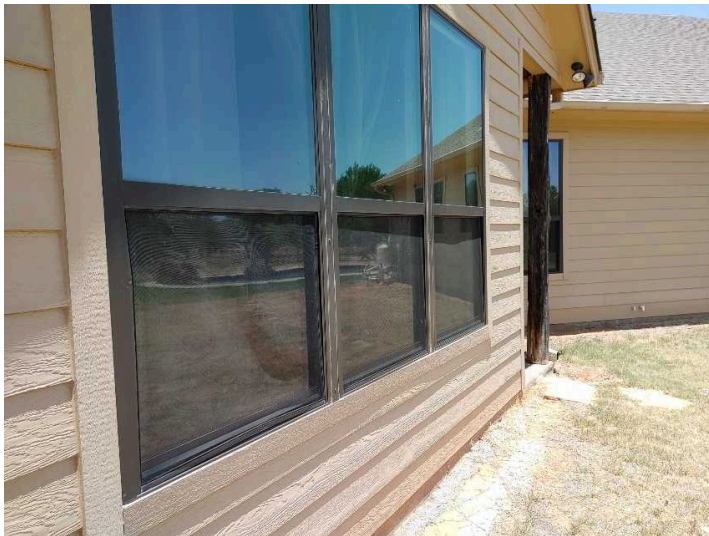
*Lost seal(s) between glazing may occur during temperature changes*

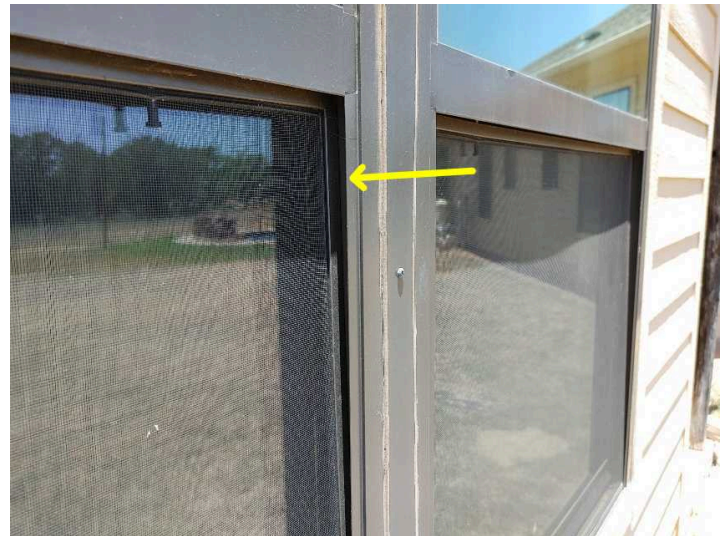
- Windows are metal or aluminum
- Windows are double hung type
- Double-pane Gas filled and/or low-emissivity type windows. (Low - E Rating)
- **One or more of the window screens were observed to be damaged and/or missing**

*Loose or damaged screens at various exterior location(s)*

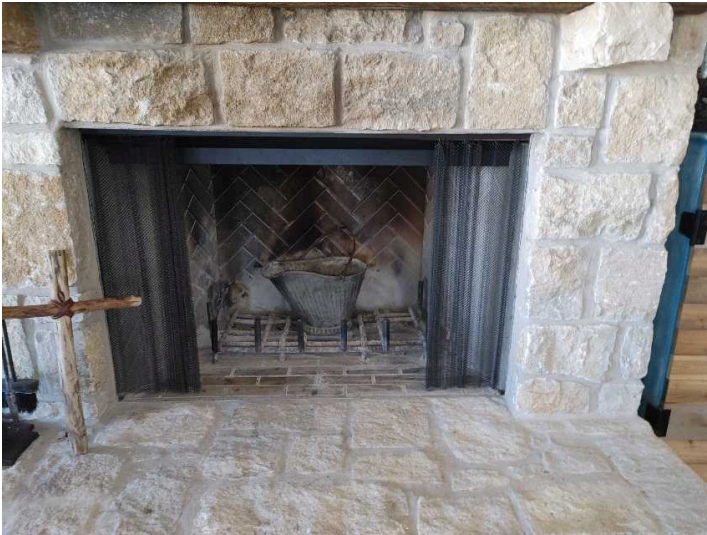
*Glass cover should also be applied to front of firebox for additional protection from fire hazards*

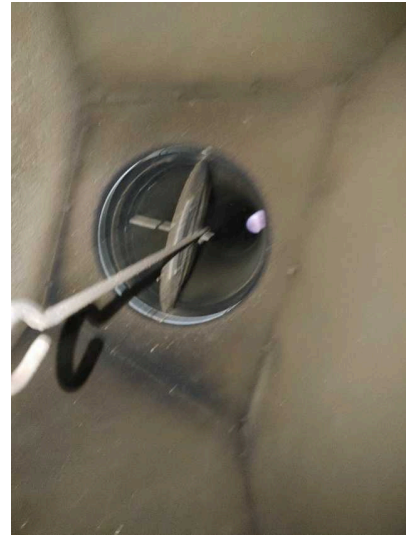
*Creosote should be cleaned from chimney before further usage*

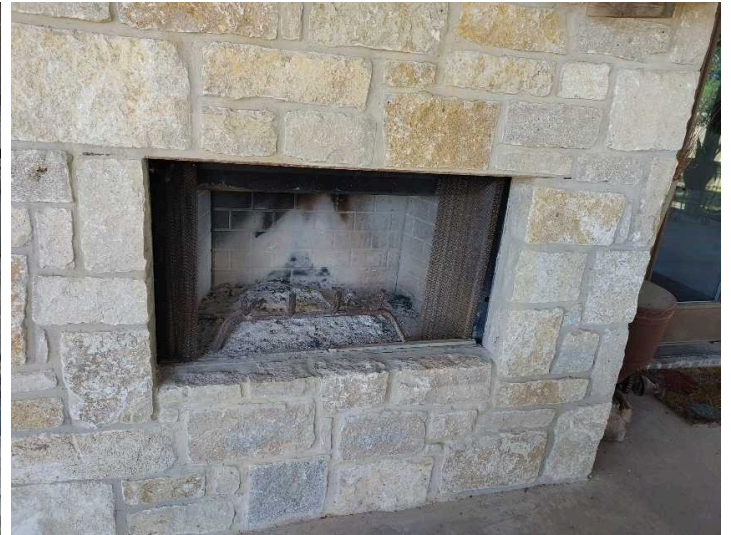
*Glass spark arrester is also advised*

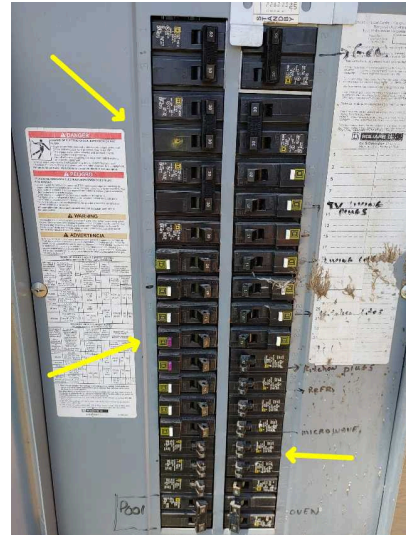
Breaker panel(s) missing labeling identification

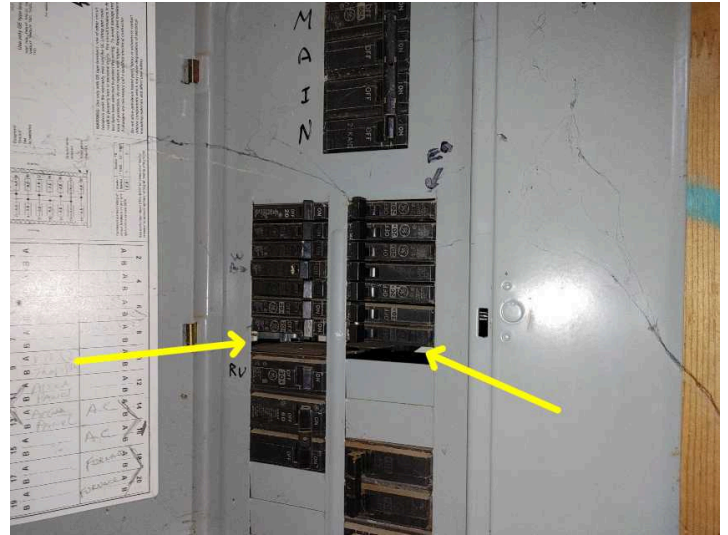
Open breaker slots should be covered for safety reasons

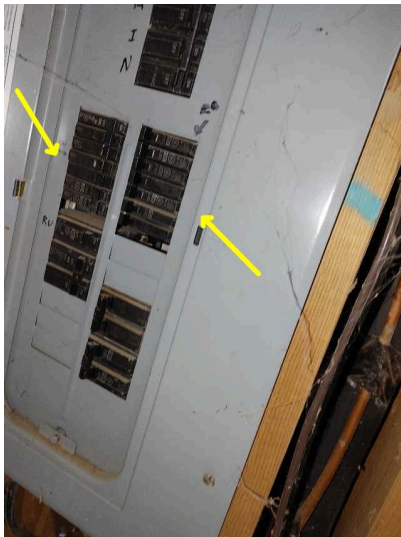
Service main in garage missing labeling identification

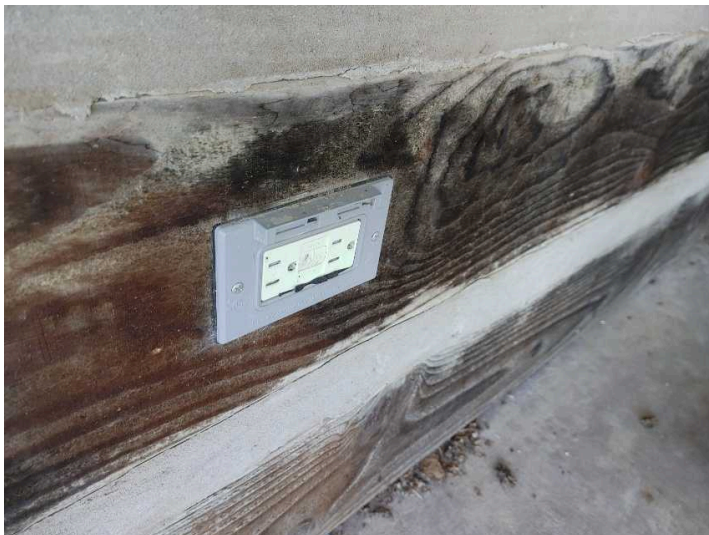
Missing cover-plates at exterior plug outlet

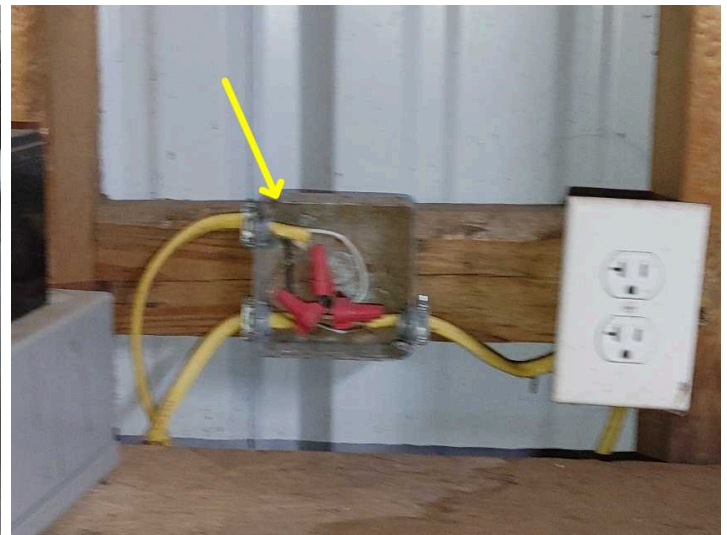
Missing cover at junction-box

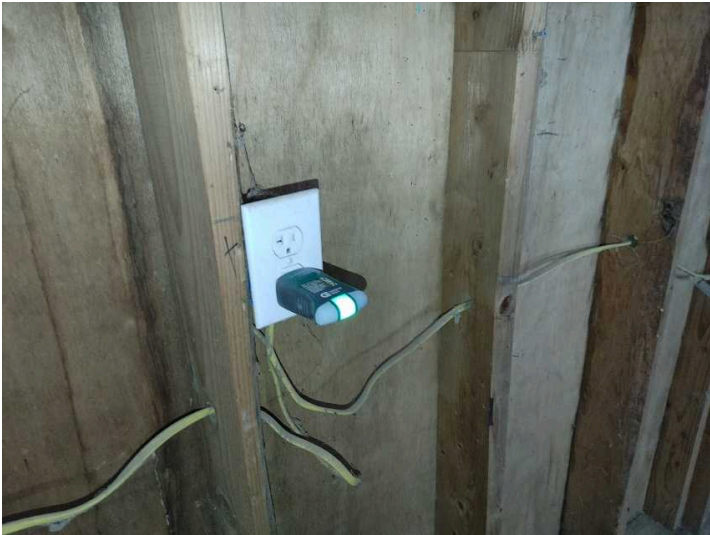
Electrical outlets in garage should be GFCI protected for safety reasons

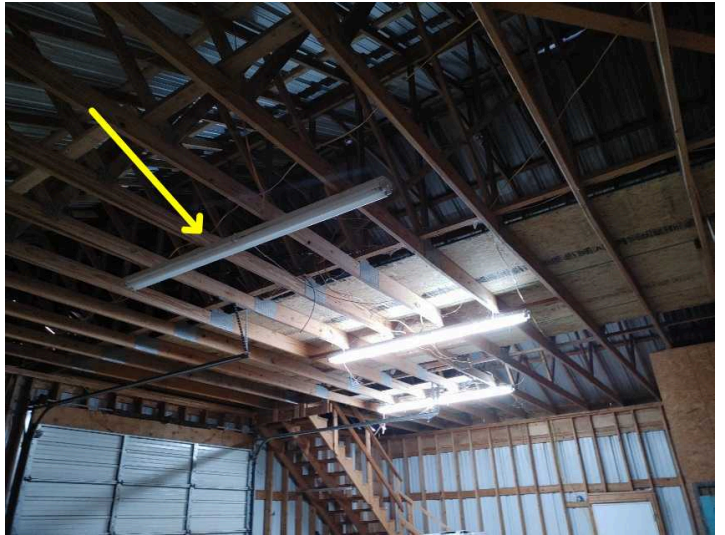
Fluorescent light fixture(s) inoperative at garage

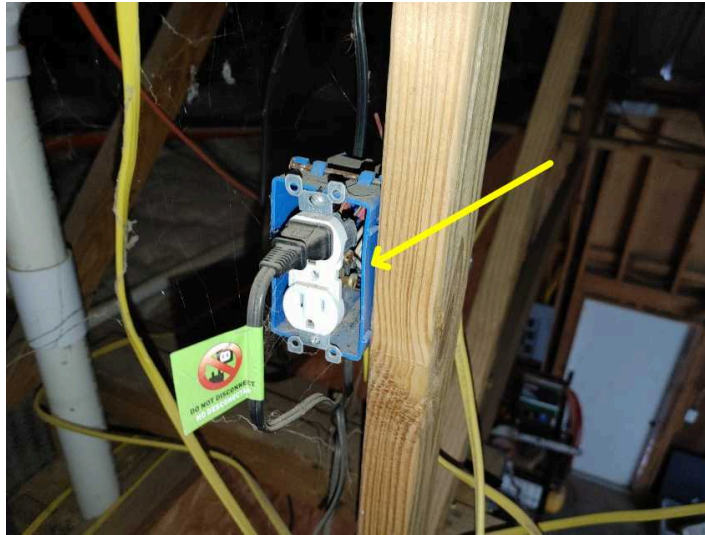
Various plug outlet covers missing at garage-barn location(s)

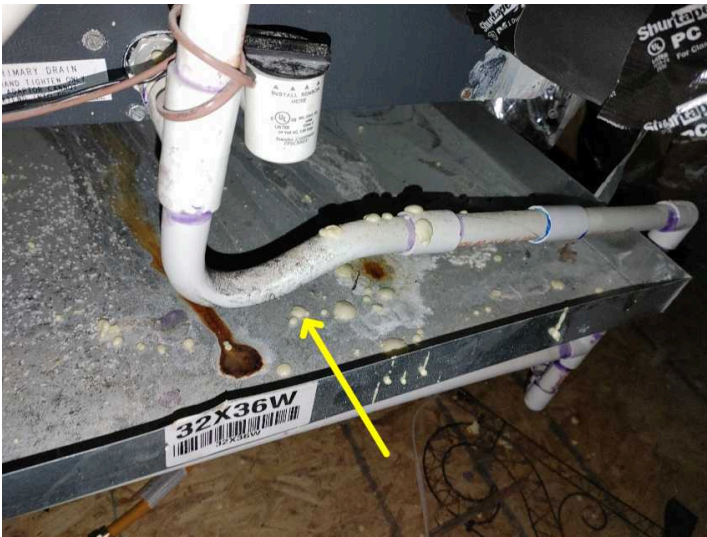
*Insulation tubing should be applied around primary drain to prevent condensate blockage*

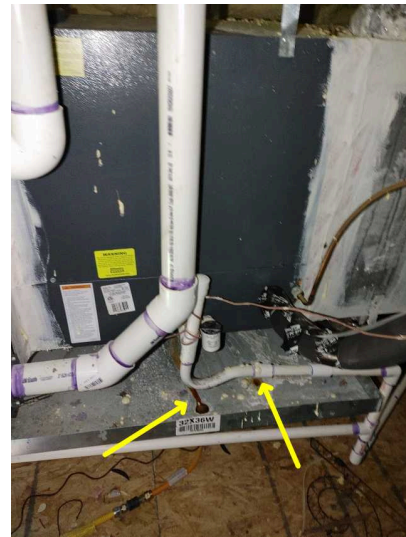
- **Rust and/or corrosion noted at interior condensate drip pan location(s)**

*Rust noted in the pan at main structure*

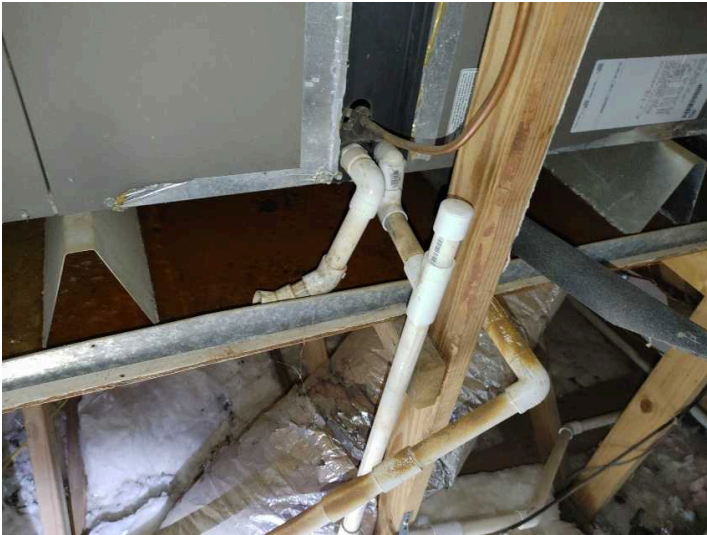
- Thermostat Locations: Interior Hallway and guest house
- Primary condensate line drains out onto permeable ground
- **Condensate drain pans are missing HVAC wet float switches in attic at garage-barn**

*Shutoff sensor should be applied to the condensate pan or at the backup drain*

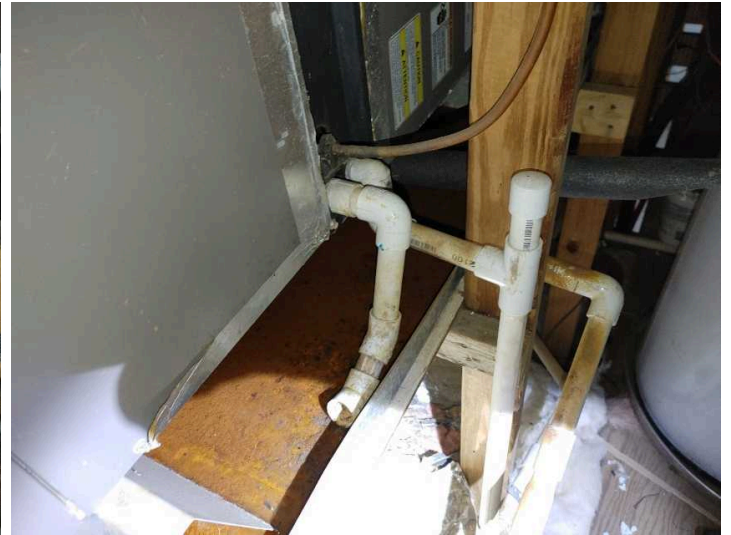
- **No P-Trap was visible on the condensate line and is required under current mechanical standards**
- **The condensate pan was observed to be holding water and should be corrected before further usage at garage-barn**

*Standing water and rust in the drip pan should be cleaned before further usage*

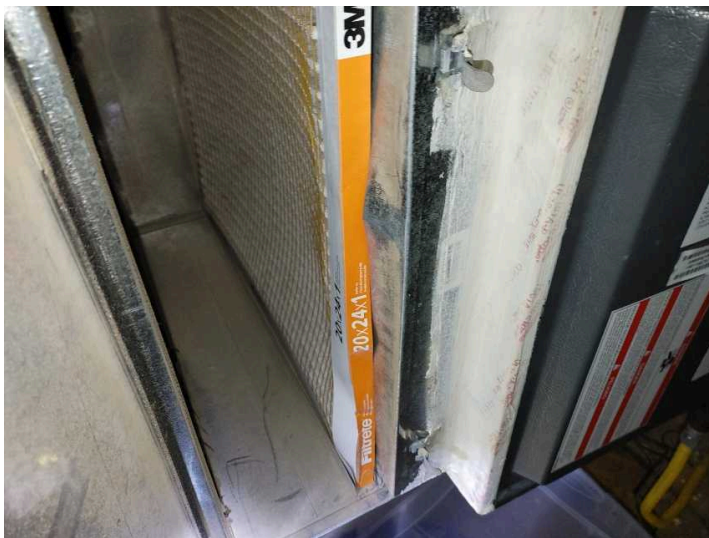
Filter replacement at main structure is advised

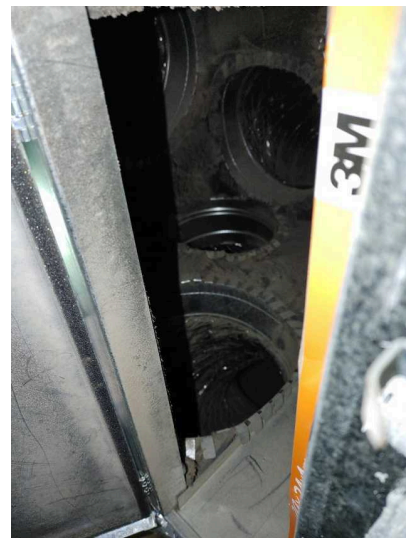
Duct cleaning advised at main structure

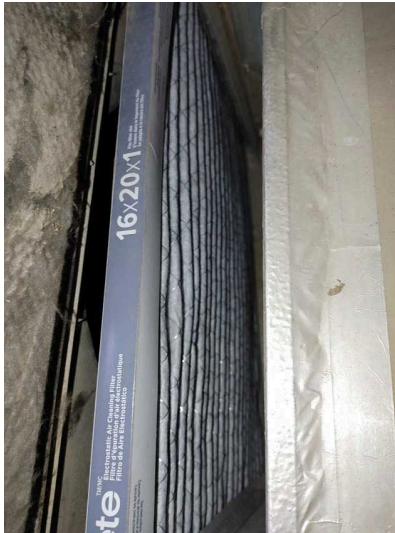
*Filter replacement advised at the garage-barn location*

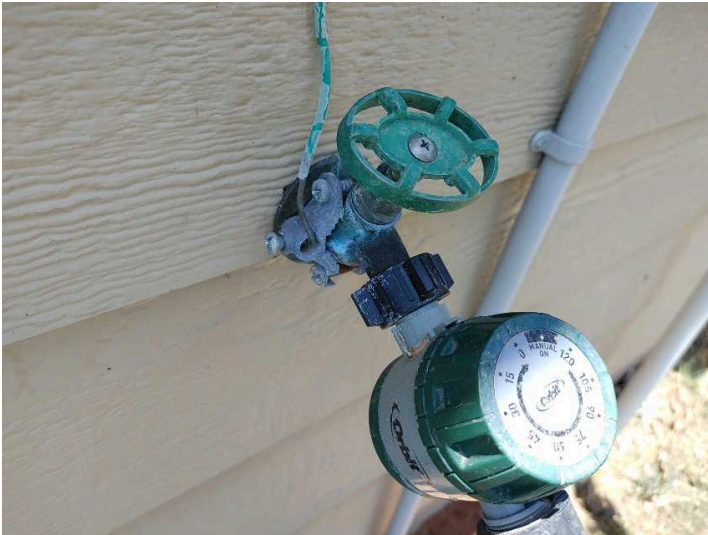
*Missing backflow devices at exterior hosebibs*

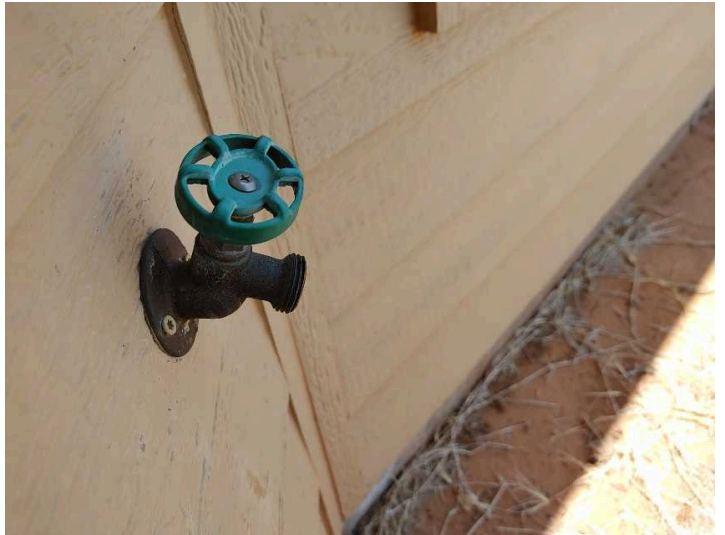
*Backflow prevention advised at exterior hosebib*

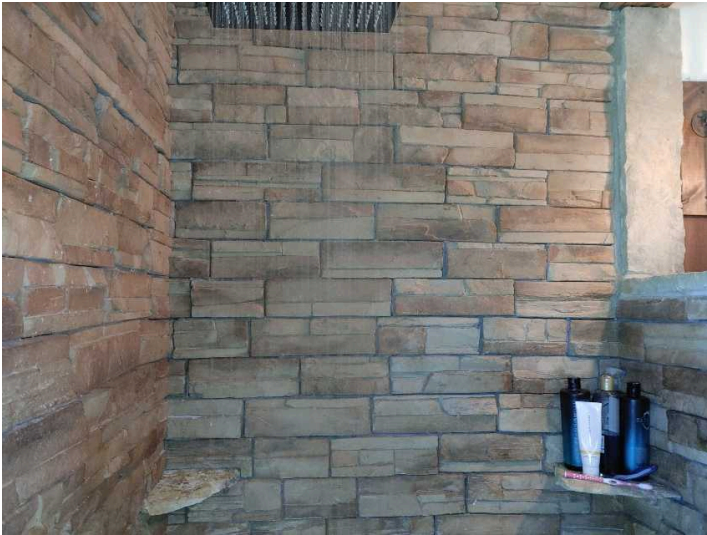
*Grout missing between stones at interior shower*

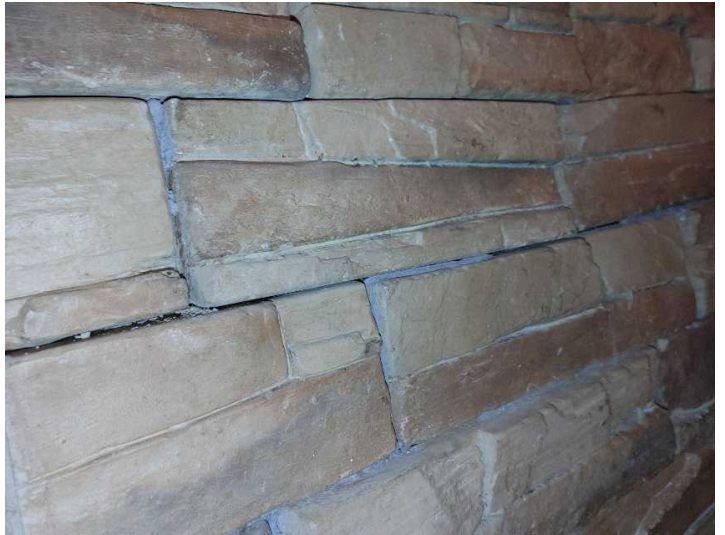
*Grout deterioration between stones inside shower enclosure*

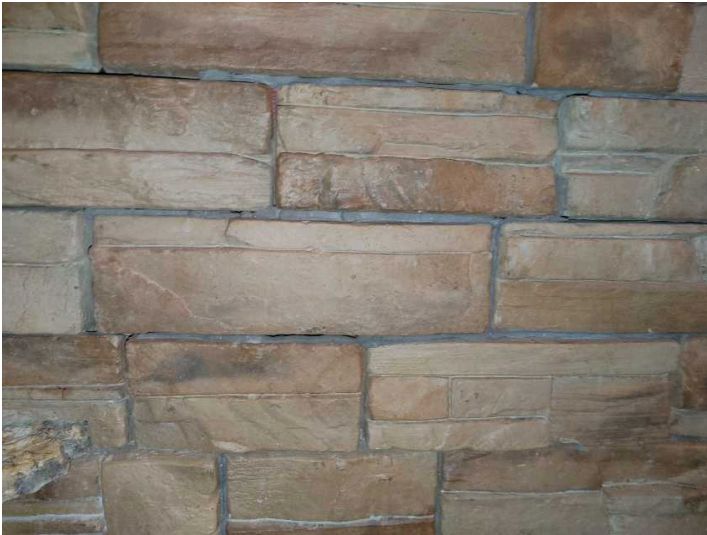
*Various stones appeared loose at interior shower enclosure*

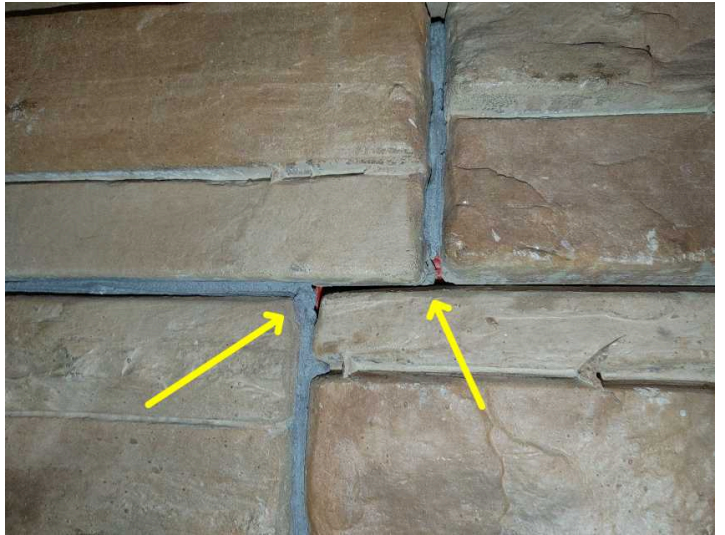
*Openings in grout seams between stones at main shower enclosure*

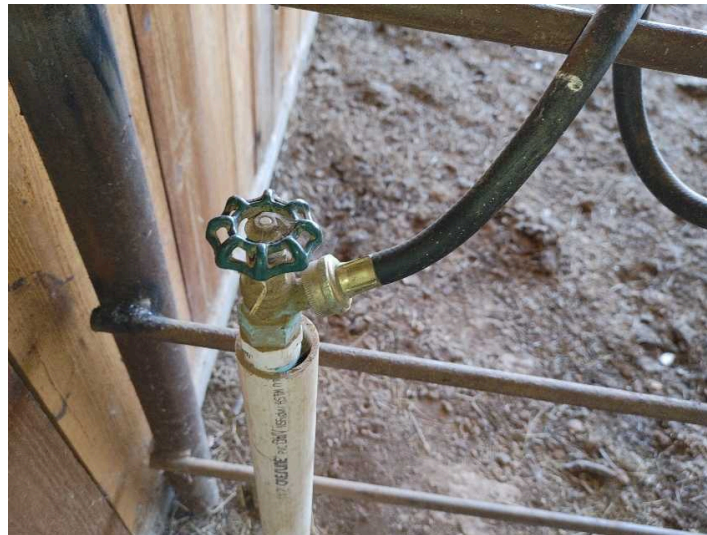
*Backflow prevention advised at each exterior hosebib*

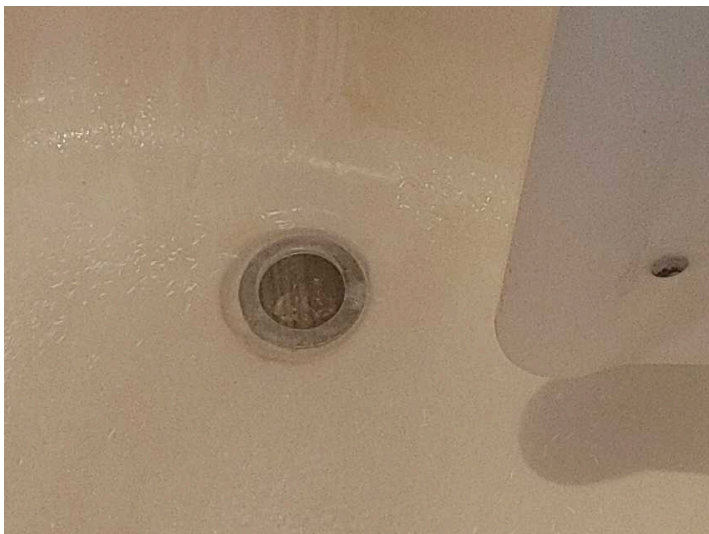
*Missing drain stop at tub basin*

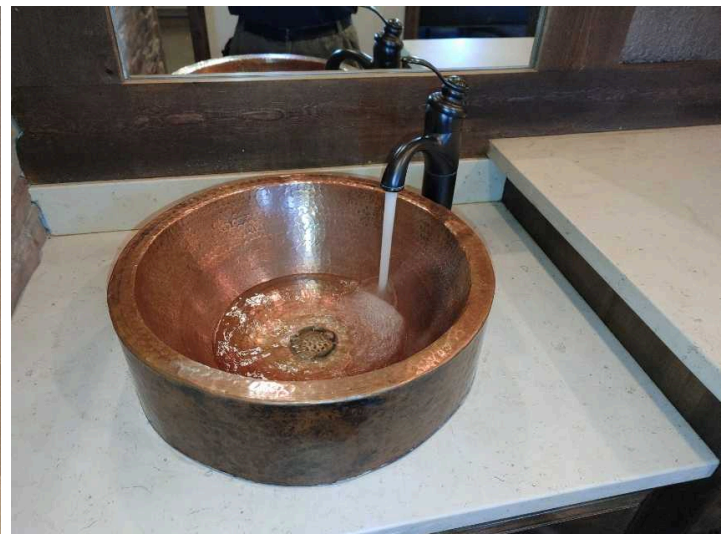
- **Missing drain stops (Pop-up Assemblies) at all vanity basin location(s)**

*Missing drain stop devices at bathroom vanities*

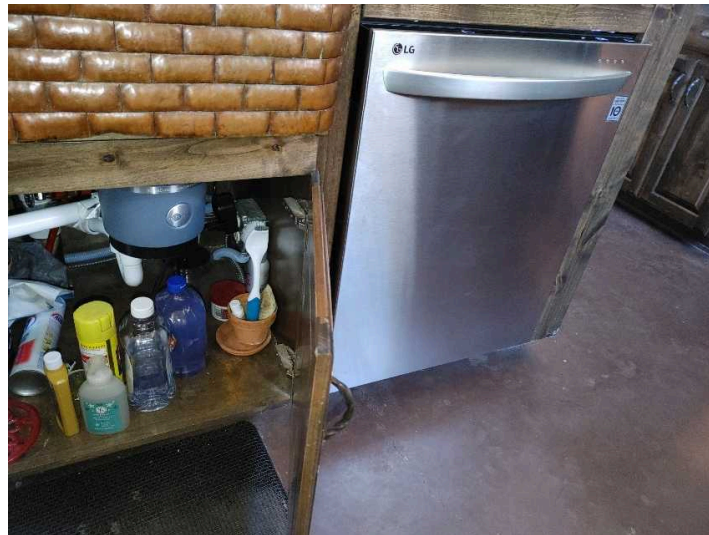
- **Lack of a proper air gap noted and/or high loop drain line at dishwasher**

*Backflow prevention should be applied*

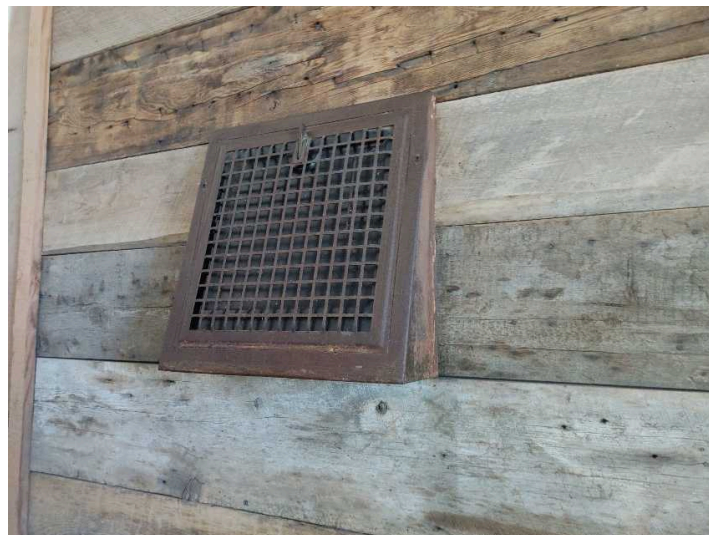
*Missing venthood at kitchen cook top*

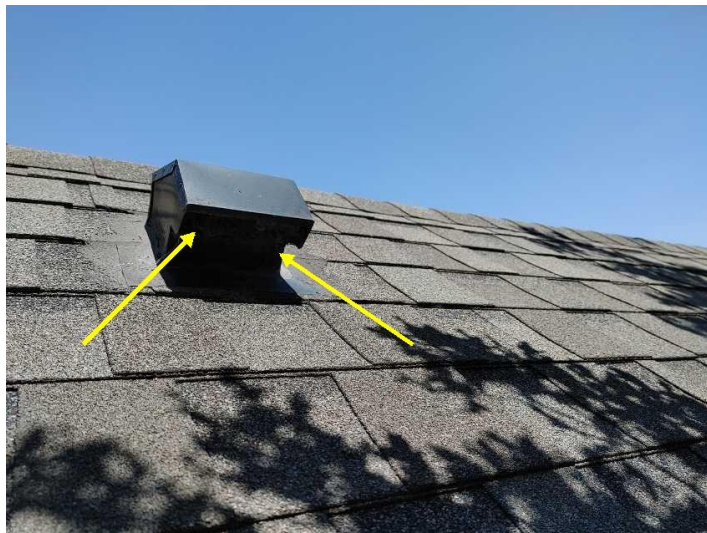
• **Dryer duct appears restricted or terminates at roof deck and extends uphill more than 25 feet**  
 • **Dryer exhaust vent termination covered by heavy lent or debris and appears restricted**

*Screened dryer vent full of lint at roof peak*

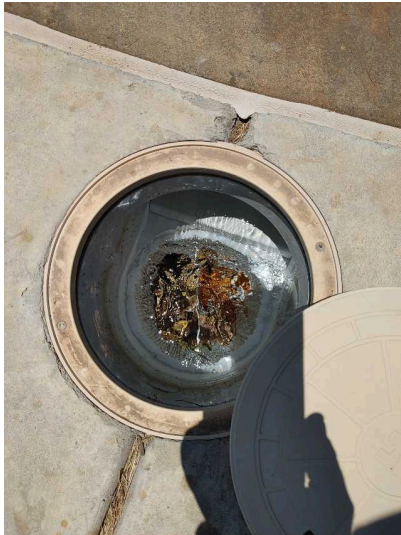
*Leaf baskets full of debris should be cleaned*

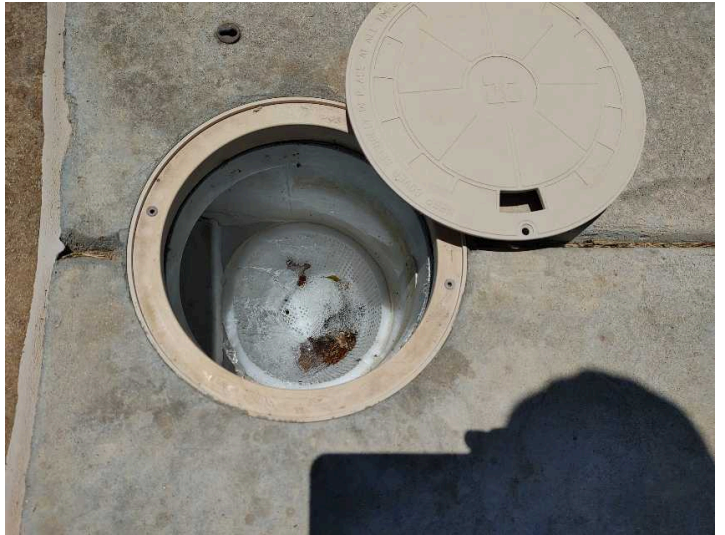
*Water level was low at time of inspection*

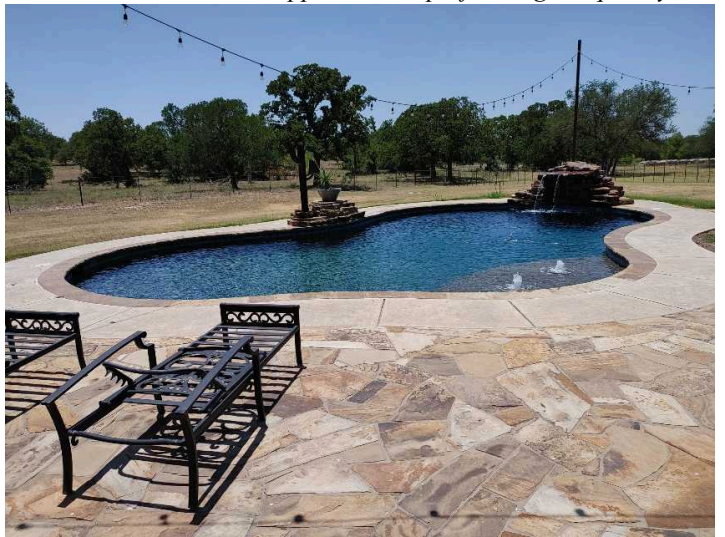
*Pool servicing is advised*

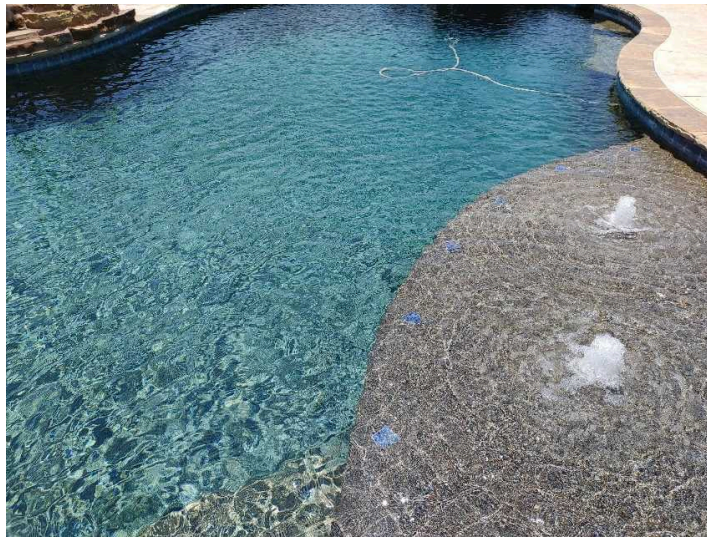
*Algae buildup around sides of pool should be cleaned*
