# *Spec-Pro Home Inspection Services*

## Property Inspection Report

1230 Bear Orchard Rd, Granbury, TX 76048  
Inspection prepared for: Sample Report  
Date of Inspection: 6/24/2022 Time: 1pm  
Age of Home: 2016 Size: 3,750 sqft  
Weather: Clear and Hot (102°F)  
Single-Family, 3-Bedroom, 3-Bath,  
House Faces: North  
Number of Persons on Property: 4

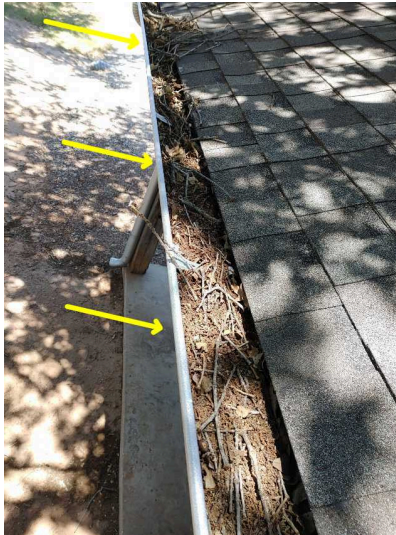
*Rain gutters full of tree limbs and debris*

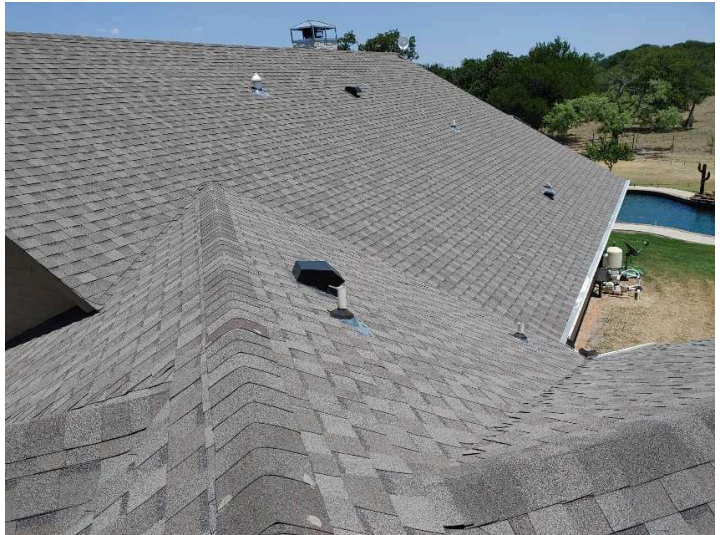
*View from West side of roof*

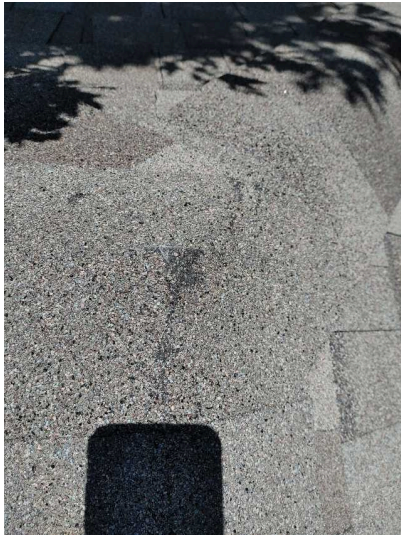
*Fiberglass strand exposure at end of peak(s)*

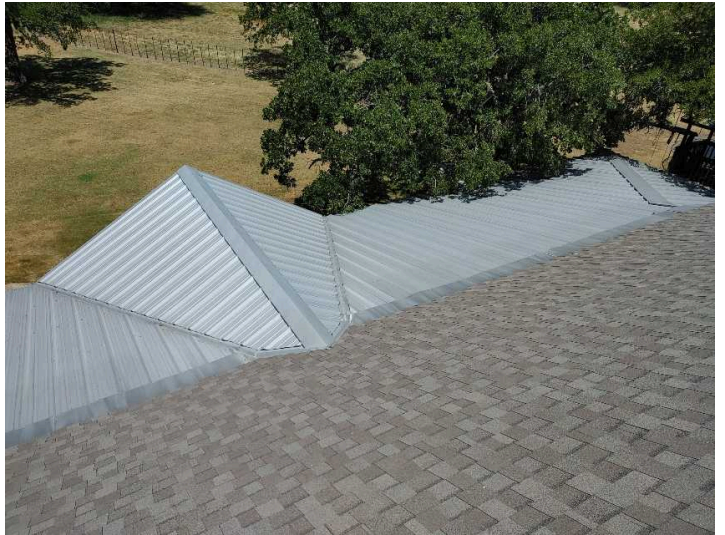
*Metal-tin roof located over porch coverings (Adequate)*

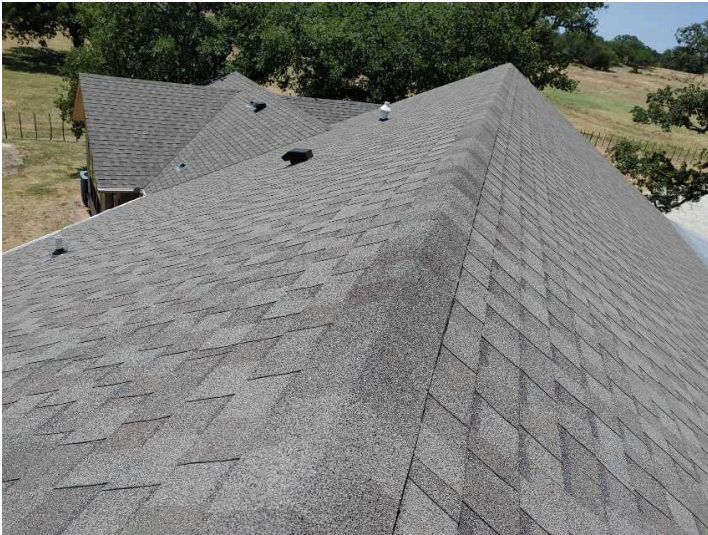
*View from East side of roof*

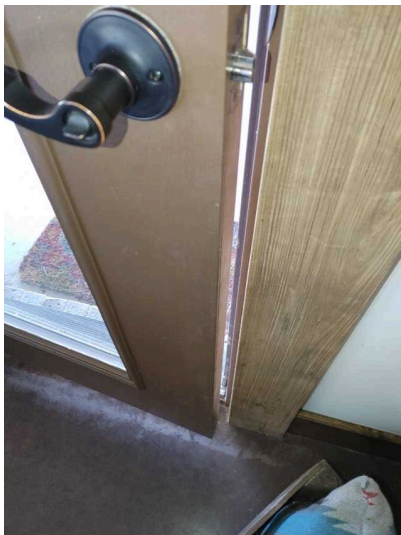
- **Some doors were inoperable and/or did latch properly**
- **Entry door catches around door jamb or requires force to open at side of structure**

Side entrance door catches at threshold

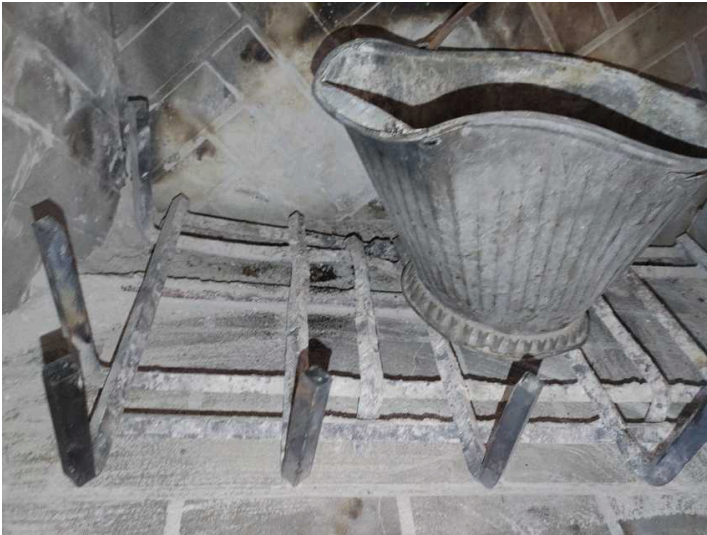
*Outdoor fireplace appears adequate*

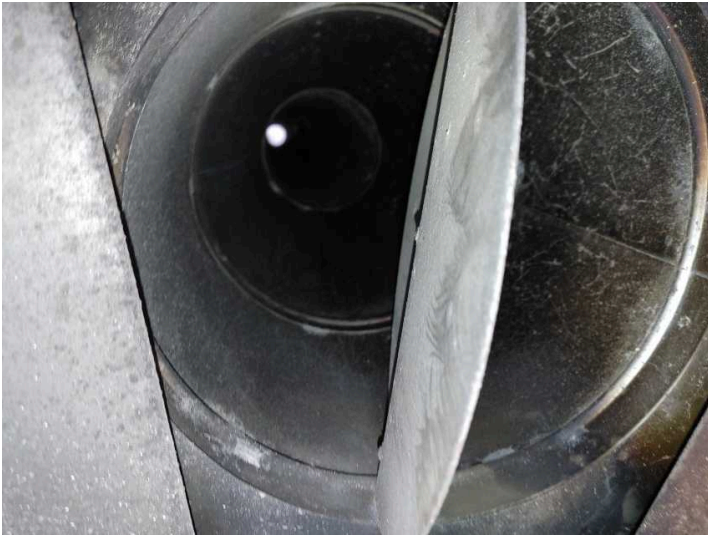
*Flue to outdoor chimney appears adequate*

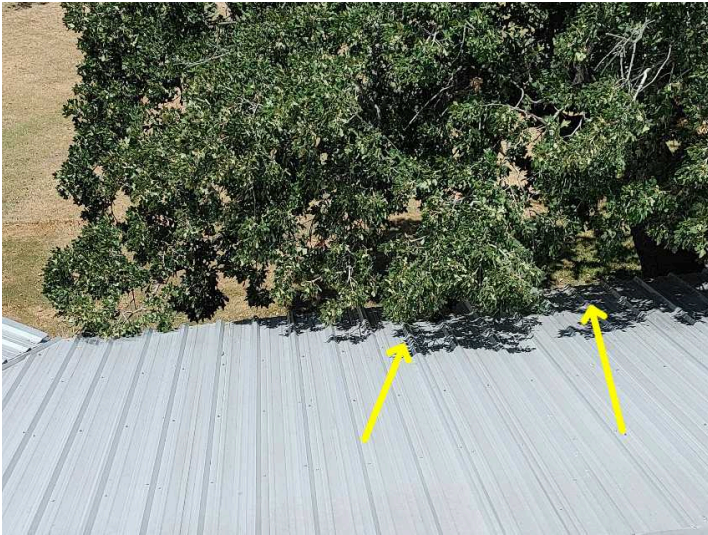
- There was an attached front and rear porch covering
- **Tree limbs in contact with metal covering should be trimmed back from the roof deck**

*Tree limbs in contact with metal porch awning should be trimmed back minimum 6' from the covering*

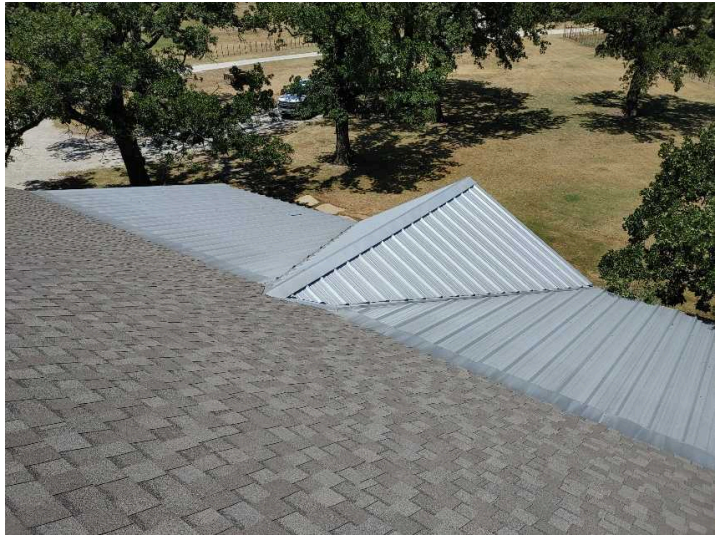
*Metal roof covering at front porch appears adequate*

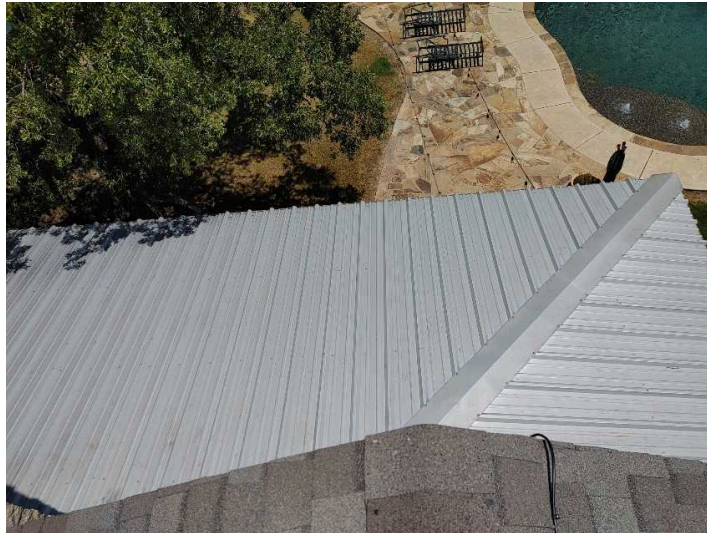
*Metal roof covering at side porch appears adequate*

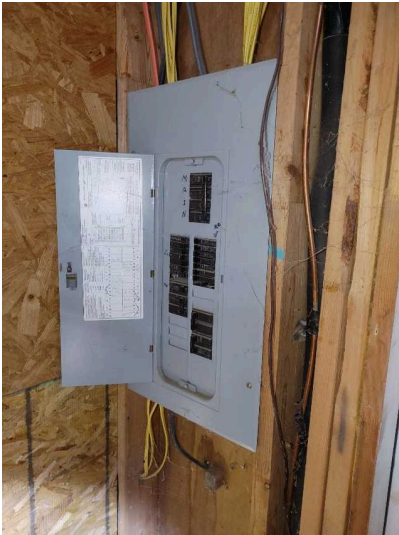
Service panel #2 located at garage-barn location (Adequate)

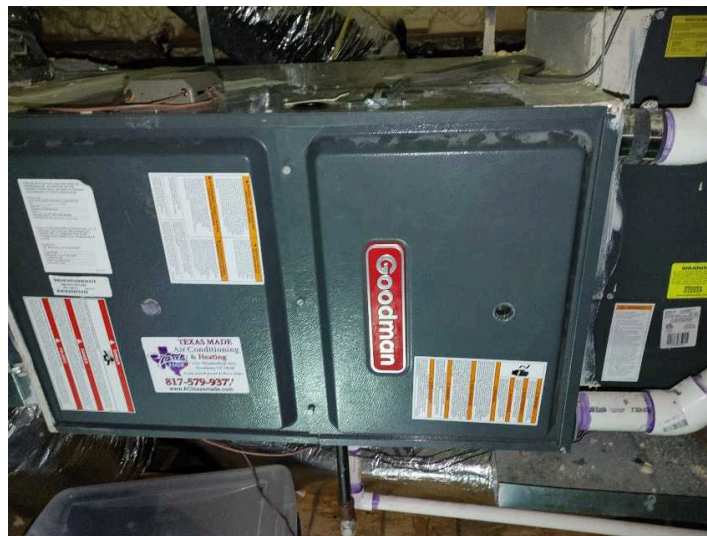
*Furnace to main structure is LP Gas*

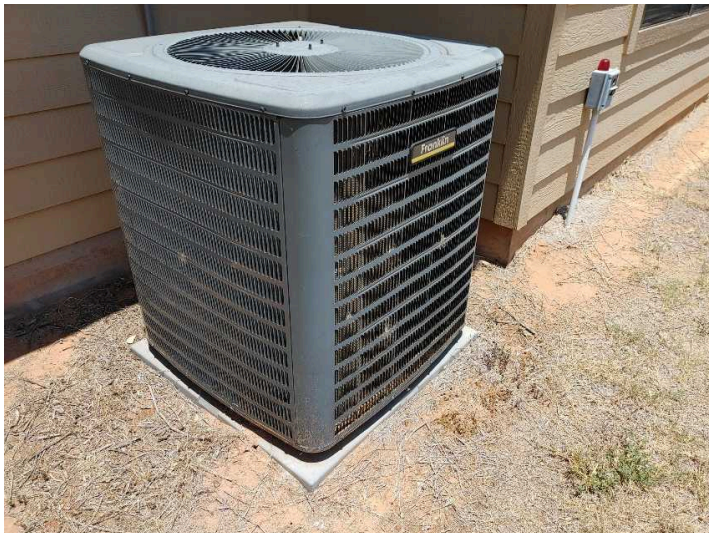
Outdoor condenser-unit located at rear of main structure

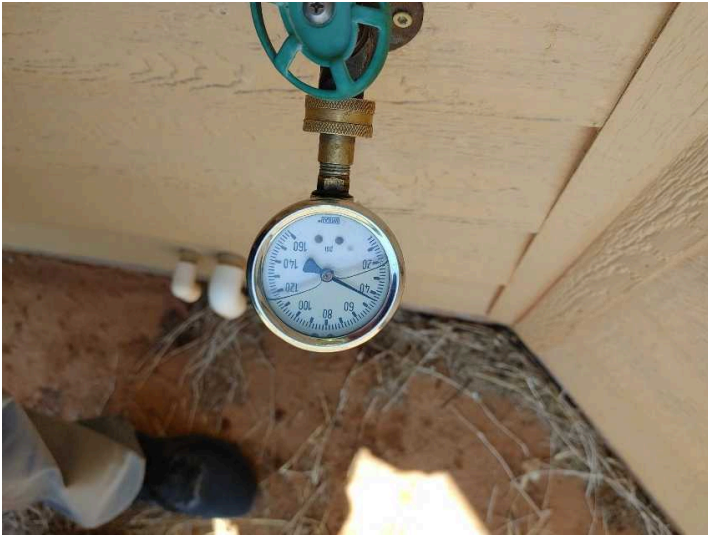
*Static water appears adequate*

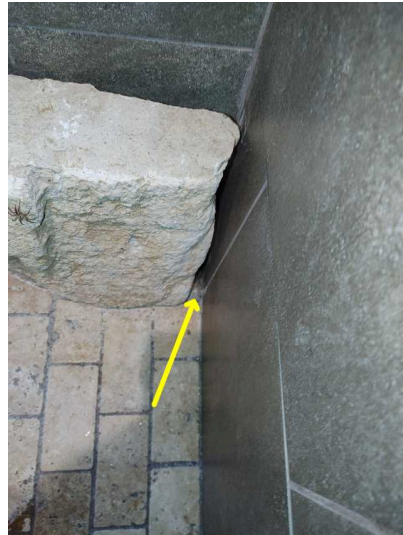
*Openings around shower enclosure*

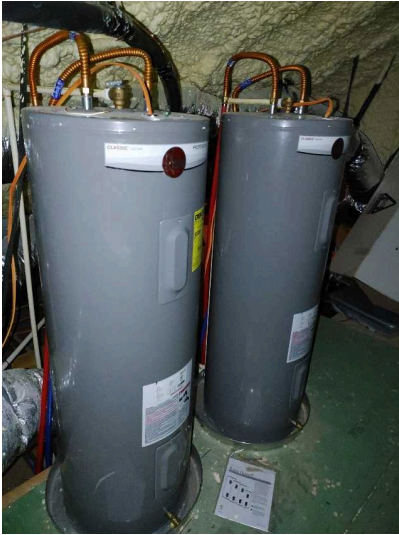
2-50 Gallon Electric Water Heater Units located in attic

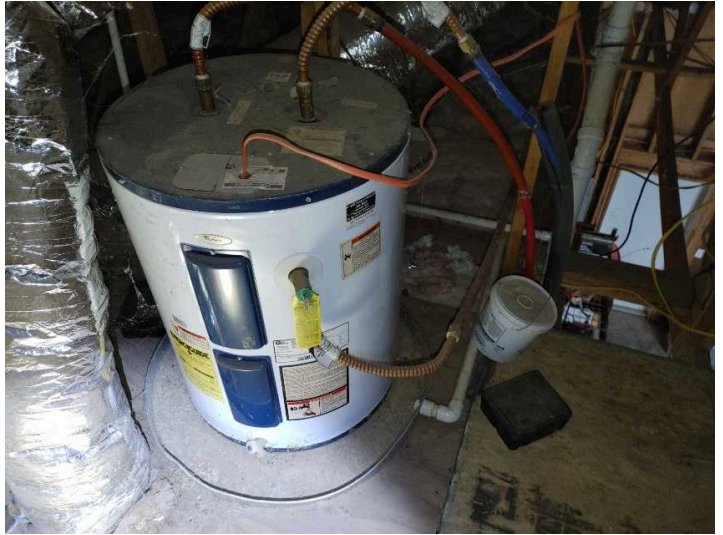
Older electric water heater unit located at garage-barn location

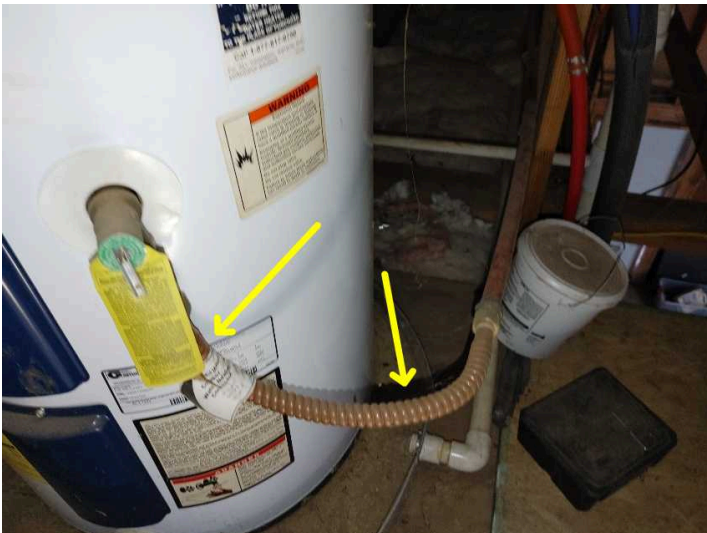
- Improper components used for the T&PR Valve discharge drainage line and also appears to be reduced in size at the termination point exterior of structure

TPRV reduced in size at the 38 gallon water heater unit

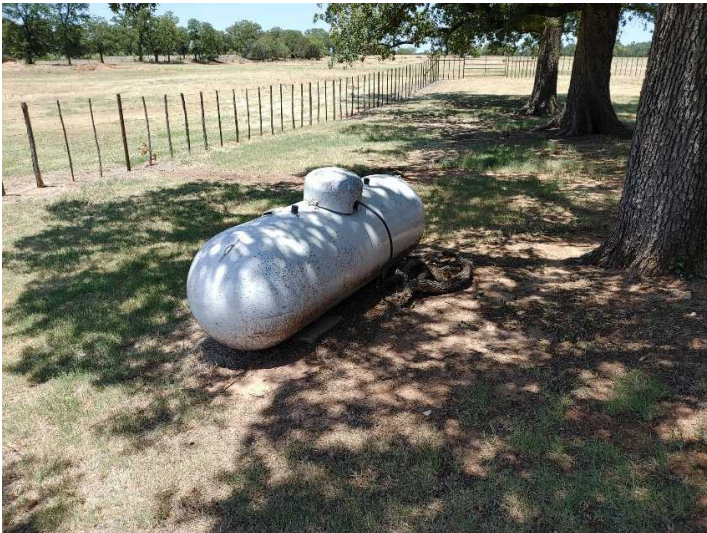
- Above ground horizontal high capacity "torpedo tank" appears to be performing adequately (No gas leaks)

Propane storage tank located NW of structure

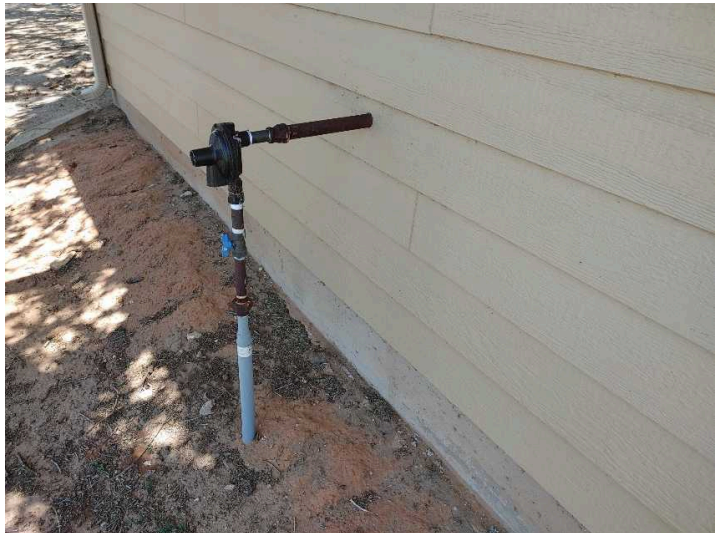
LP gas inlet line to structure appears adequate

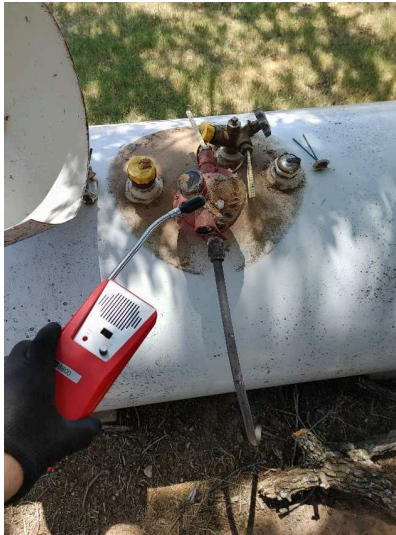
*No gas leaks were detected*

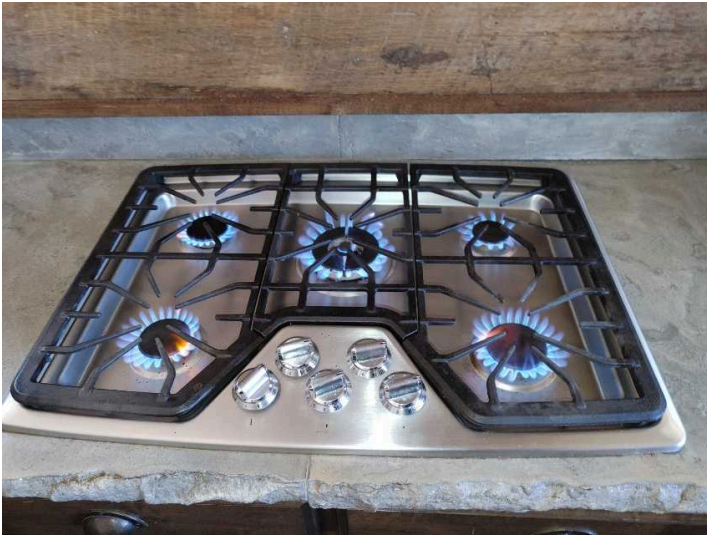
*LP Gas cook top appears to be performing adequately*

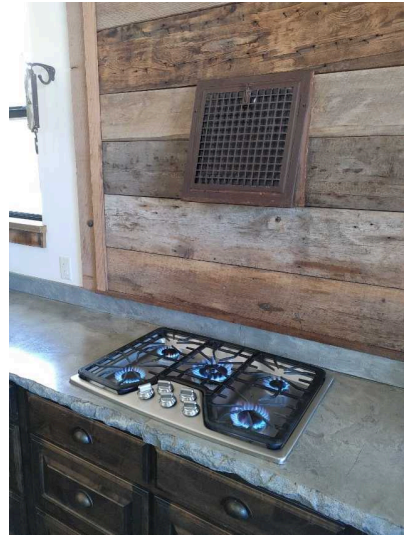
*Gas fired appliances should have a method to vent out exhaust*

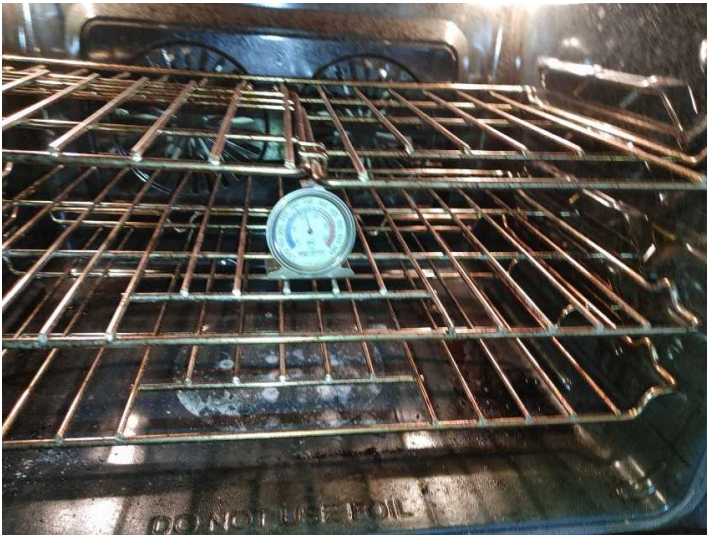
*Top oven heating adequately*

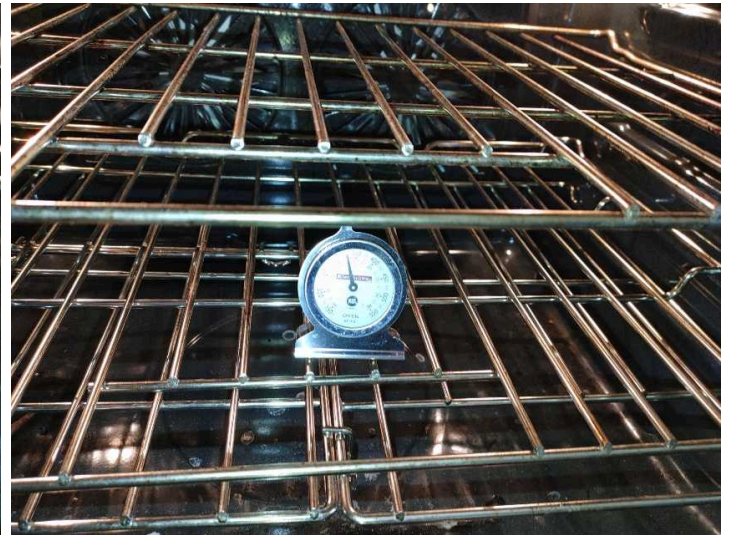
*Bottom oven heating adequately*

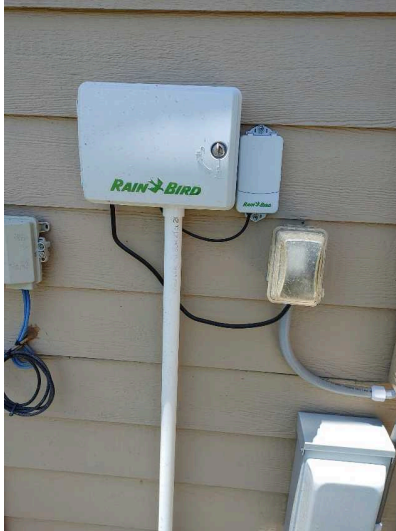
- The sprinkler system appeared functional and was tested in the manual setting only

*Lawn irrigation equipment performed adequately*

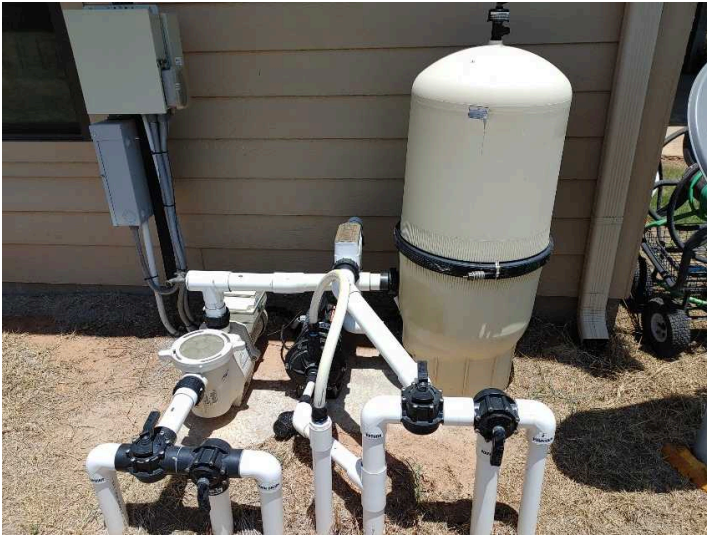
*Pool equipment should be protected from UV exposure*

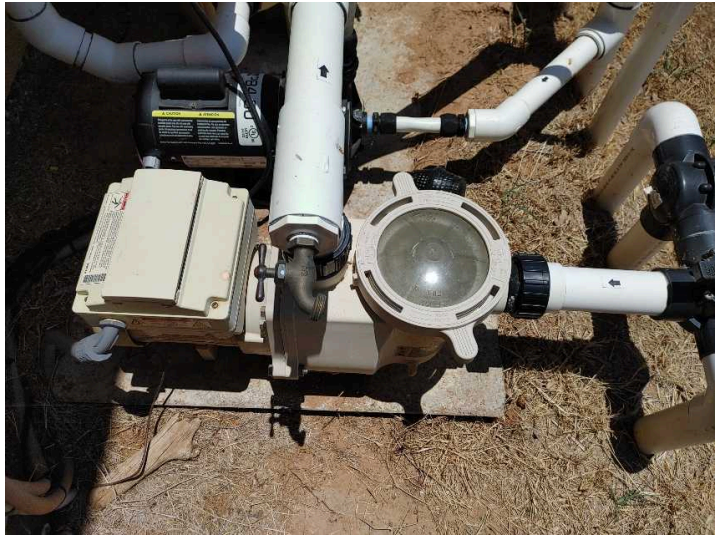
*Variable speed pump motor and skimmer performing adequately*

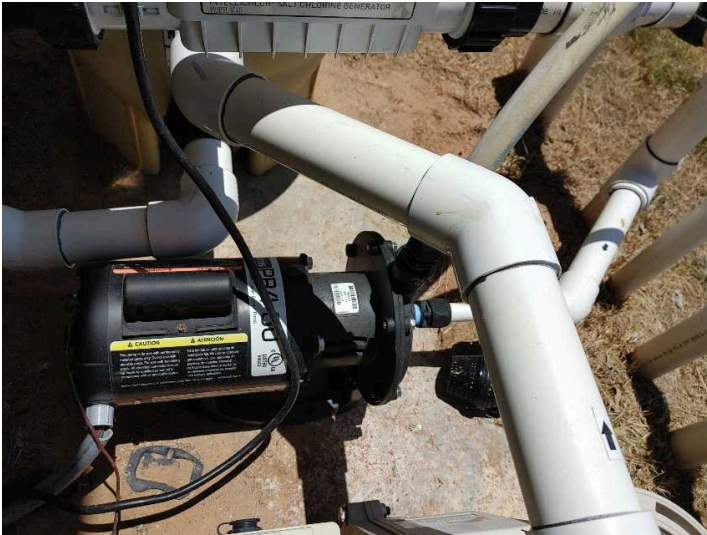
*Booster pump performing adequately*

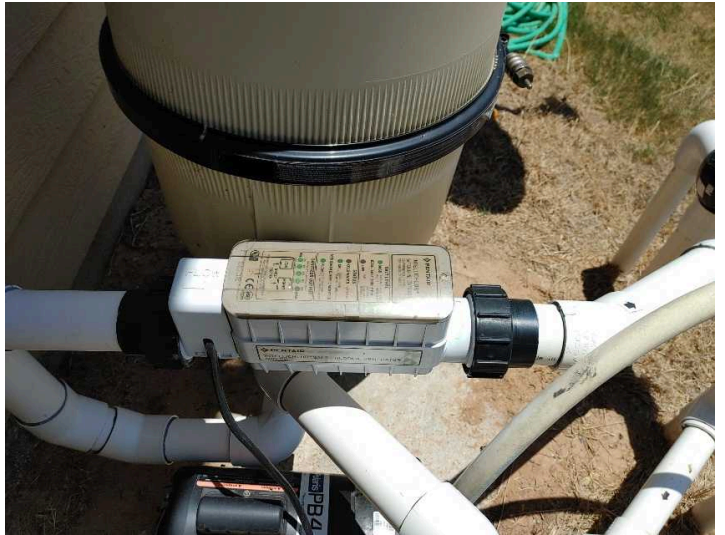
*Salt-cell/Chlorinator appears to be performing adequately*

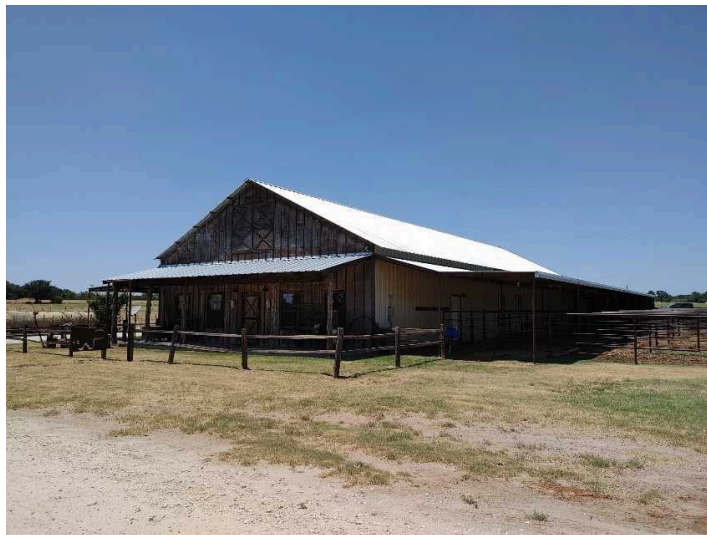
- Metal shed at front of property
- Metal roof was observed on shed

*Guest House/Barn/Garage situated North side of property*

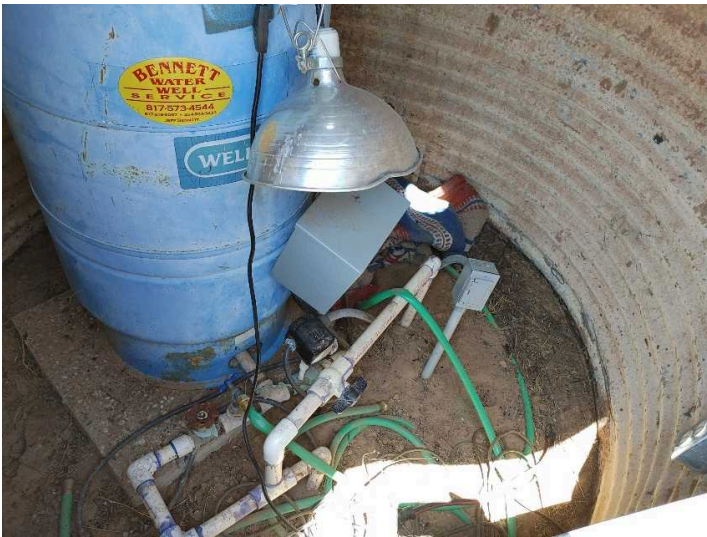
*Pressure tank appears adequate*

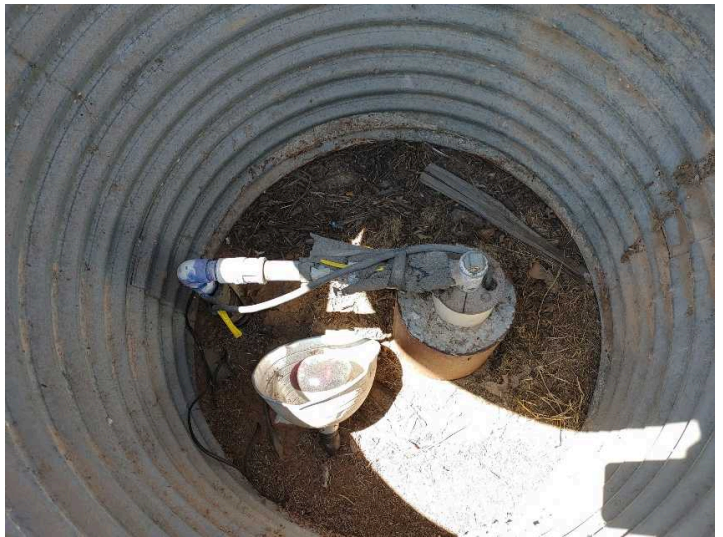
*Drilled well and sanitary cap located at front of property*

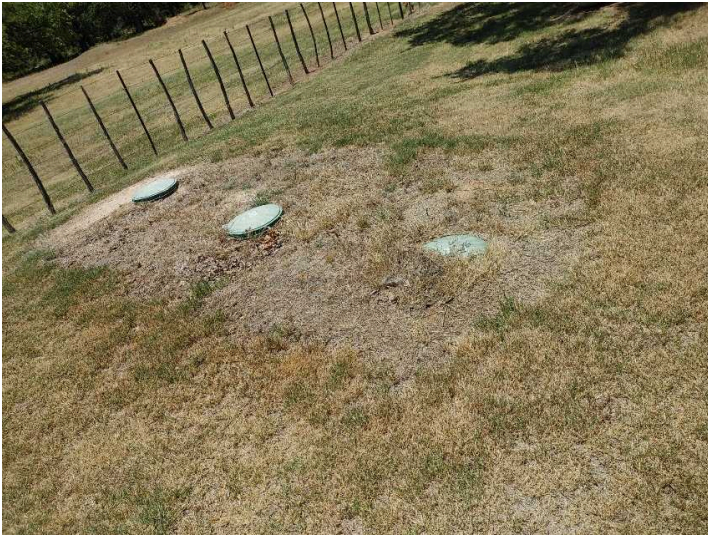
*Septic tank situated rear of structure at south side property*

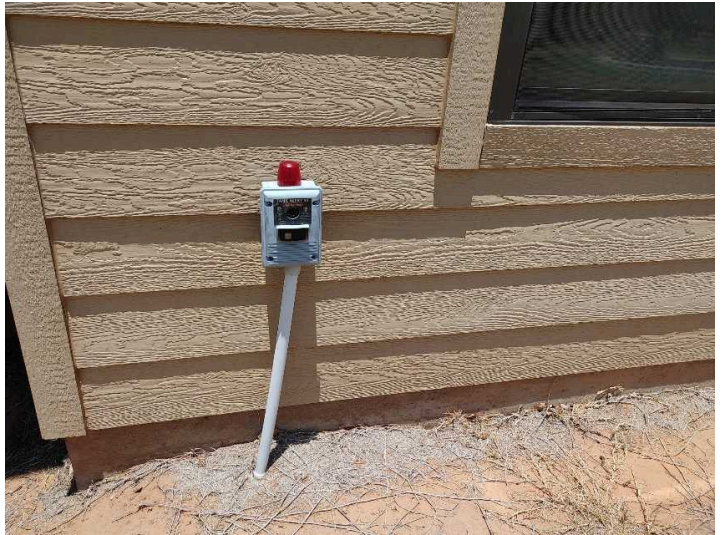
*Septic alarm appears adequate*
