# *Spec-Pro Home Inspection Services*

## Property Inspection Report

1230 Bear Orchard Rd, Granbury, TX 76048  
Inspection prepared for: Sample Report  
Date of Inspection: 6/24/2022 Time: 1pm  
Age of Home: 2016 Size: 3,750 sqft  
Weather: Clear and Hot (102°F)  
Single-Family, 3-Bedroom, 3-Bath,  
House Faces: North  
Number of Persons on Property: 4

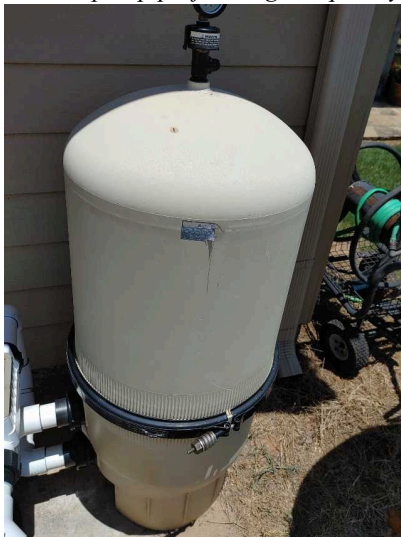
*DE Filter tank should be backwashed monthly (Re-add DE after backwashing)*
